OBJECTIVE

In May of 2018, to independently validate the new 2-7/8 AMP, InFocus Energy Services conducted 3rd party dyno testing of the power sections at a third party provider in Red Deer, AB. The objective was to demonstrate repeatable high torque and extended run time performance of InFocus Energy's 2-7/8" AMP (ALL METAL POWER) sections.

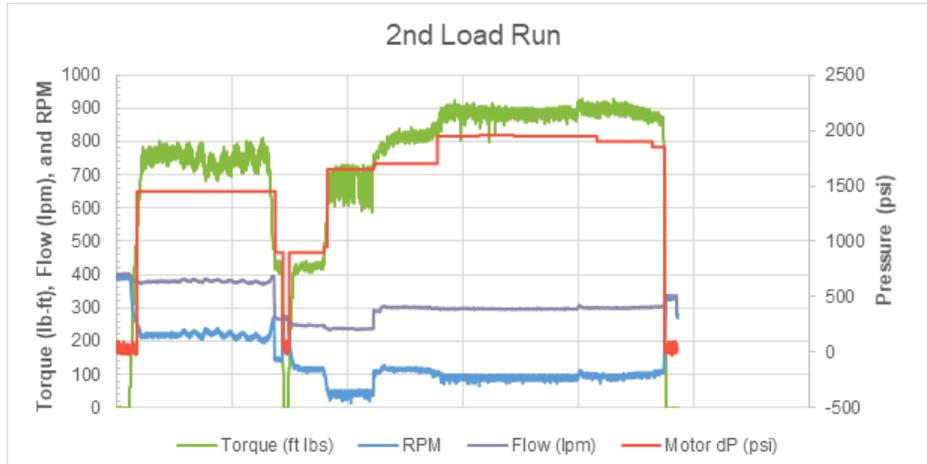
Tests were very successful and proved the AMP power section can operate at a variety of load conditions, and can transition easily between loading conditions, all while putting out very high torque for it's size in a sustained (>30min) high load test. Data from the 2nd load run, where maximum torque of 890 lb-ft was achieved and sustained, is plotted in Figure 1.

Figure 1 - Graphical results of 2nd Load Run

3. 2nd Load run – 66 GPM flow rate
 - (a) This test was started at a flow rate of 100 GPM, and the motor was held at 765 lb-ft for 10 minutes. Flow rate was then dropped to 80 GPM.

- (b) The stable load was 410 lb-ft at a diff pressure of 900 psi. This was steadily increased over 25 minutes until a torque of 890 lb-ft was reached at a diff pressure of 1,950 psi.

- (c) This 890 lb-ft load was held for over 30 minutes at a speed of just under 100 RPM with no drop in performance or change in diff pressure.

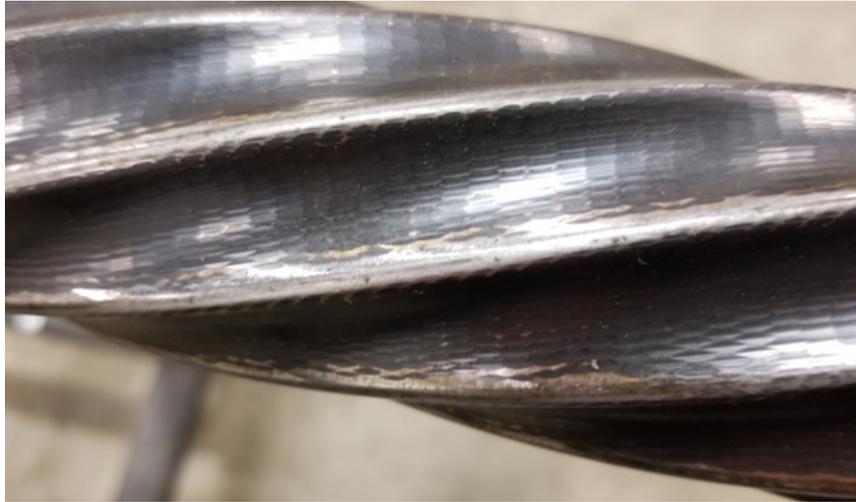
Contact appears to have occurred along one side of the profile of the rotor lobe, and in some locations extended to the rotor lobe tip. This is the side where the rotor rolls into the stator. This contact patch does not appear to have any divots or dents or even a step change in lobe thickness. The rotor profile still feels smooth and looks like the contact is more of a polish than any appreciable wear.

NOTE: The rotor was manufactured to a milled finish, resembling "snake skin". The scaling seen is from the manufacturing process and not from dyno testing.

Figure 2 - Closeup of rotor contact patch

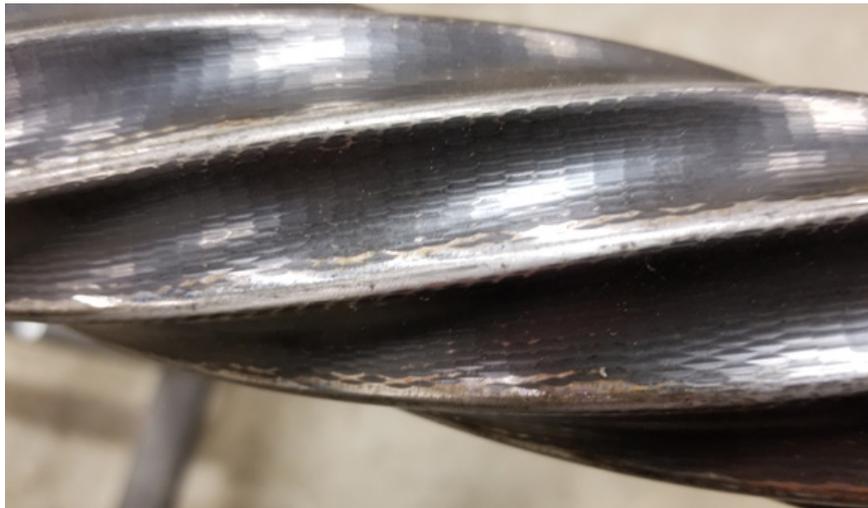
Figure 3 - Alternate view of rotor contact patch

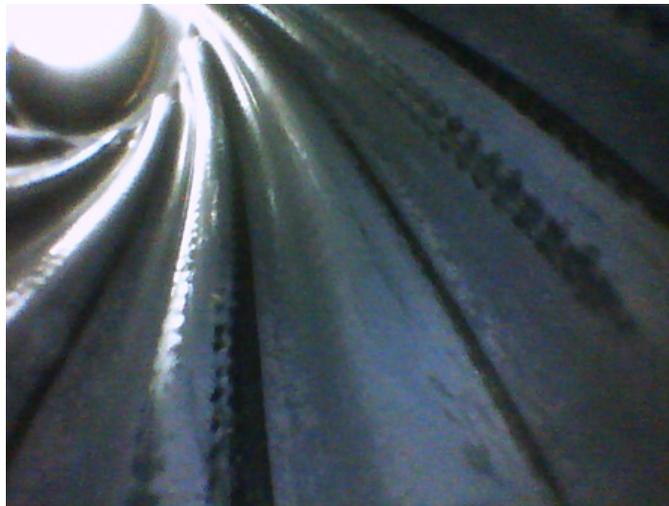
The stator was evaluated via visual inspection with a borescope, as well as tactile evaluation.

Contact appears to be on the flanks on either side of the stator minors, where the rotor makes rolling contact with the stator. The contact patches are smooth, and free of divots and dents. The edges of the contact patches are gradual and no step changes or indents are visible. This wear pattern is consistent through most of the stator. As seen on the rotor, this contact appears to be mostly polish rather than any appreciable wear.

Figure 4 - Post-run borescope of stator

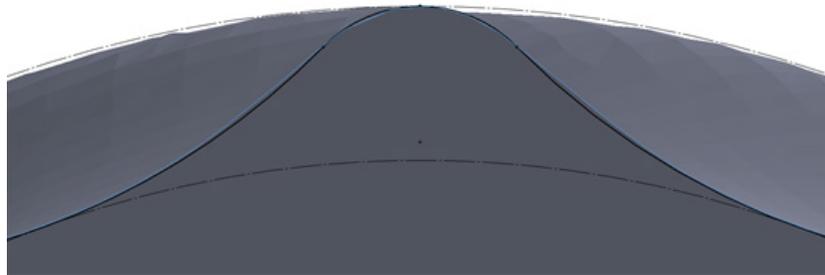
The initial laser scan, taken directly after manufacturing, showed the minors to be exactly on size, and the majors very slightly under the maximum nominal dimension. This was consistent across most of the lobes and fell within the acceptable tolerance.

Figure 6 - Sample lobe profile after manufacturing

NOTE: It is important to note that the points are imported as a polygon mesh from the laser scan data, so there is some rounding error as the curvature of the tips are connected straight line segments rather than true, clean arcs.

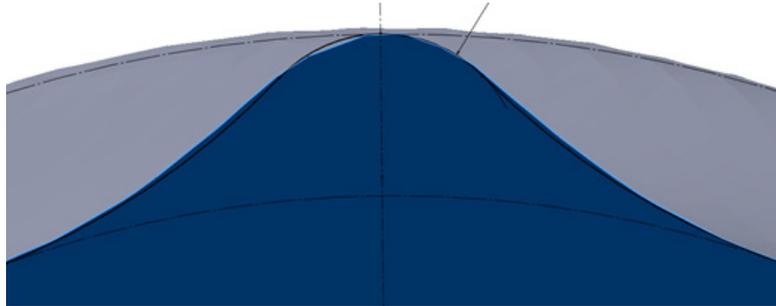
The post-dyno laser scans help quantify what was seen in the visual rotor inspection. The minors and the flanks saw no wear, and scans show them to be approximately 0.002" thicker than in the first scan. This is consistent with the expected growth due to rotor treatment. The dimensional change on the majors varied between lobe and profile location, but was generally between 0.001 – 0.002". On most lobes this contact was preferential to one side of the major, which again lines up with the visual inspection and the side of the major that would roll into the stator.

Figure 7 - Sample lobe profile after dyno testing

Although 0.001 – 0.002” dimensional change was observed on most majors, it is unlikely that this change would continue to progress at the same rate. In the final dyno test of the day, maximum torque of 890 lb-ft was achieved and held for a period of over 30 minutes without any measurable decrease in performance. This may indicate that observed dimensional change is initial run-in of the rotor and may not lead to performance degradation over time.
