## Elastomer-less Power Section

InFocus US Patent Number US10676992B2 – Issued June 9, 2020.  
Patent Pending in Canada

**RE|FLEX Premium Drilling Motors by InFocus** are a major advancement in PDM technology. All Metal Power sections are rated to **temperatures greater than 300°C (572°F)**, so they are not susceptible to extreme temperature and most mud-related issues seen with traditional PDM's.

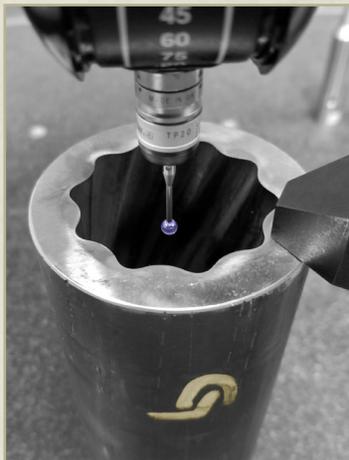
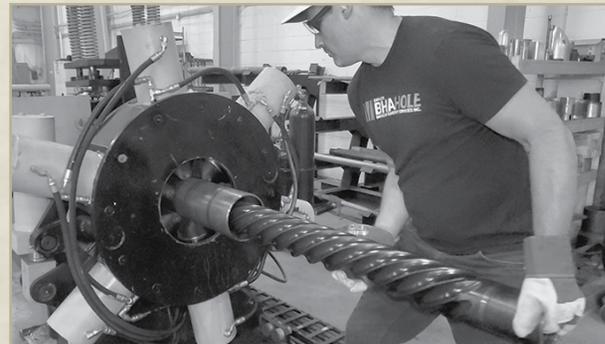
All Metal Power (or metal-to-metal) means there is **absolutely no elastomer present** within the power section, **eliminating** the greatest risk currently known to drilling motor operations - elastomeric damage.

Metal-to-Metal contact translates into **much higher operating regimes**.
